## CRUISER VIEWFINDER SIGNATURE LP COMPARTMENT REPAIR 11041R

The following steps are to ensure that the LP compartment is completely secured, as well as sealed off from the interior of the coach.

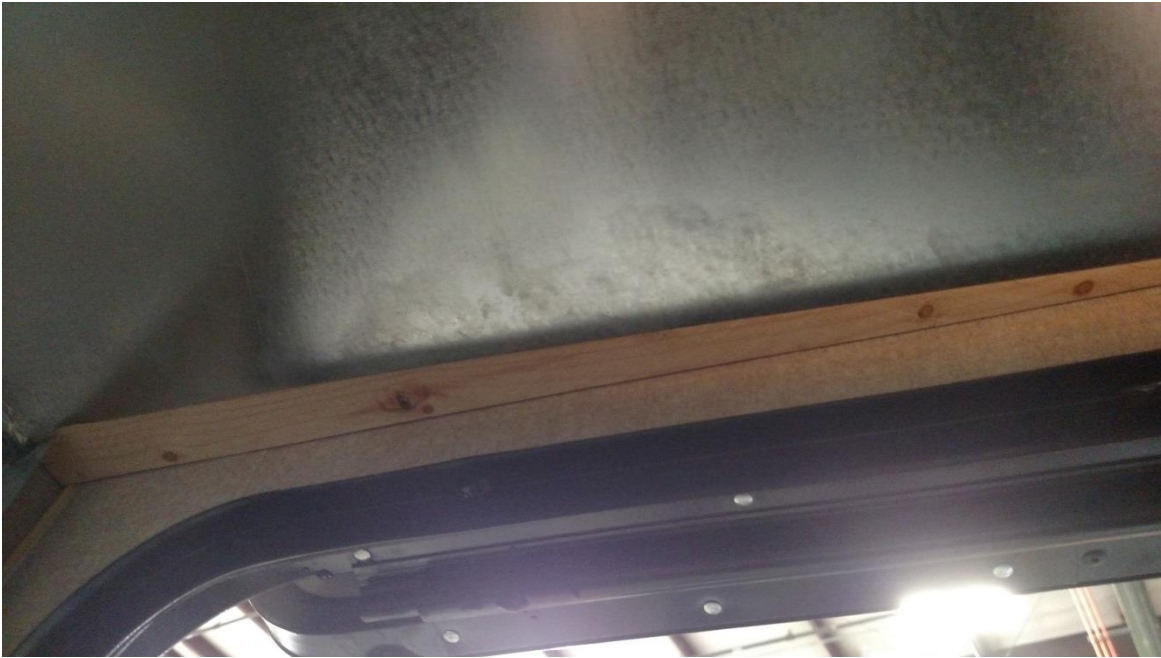
- 1.) The galvanized LP container must be securely fastened to the bed framework. The picture above shows one that has not been secured.

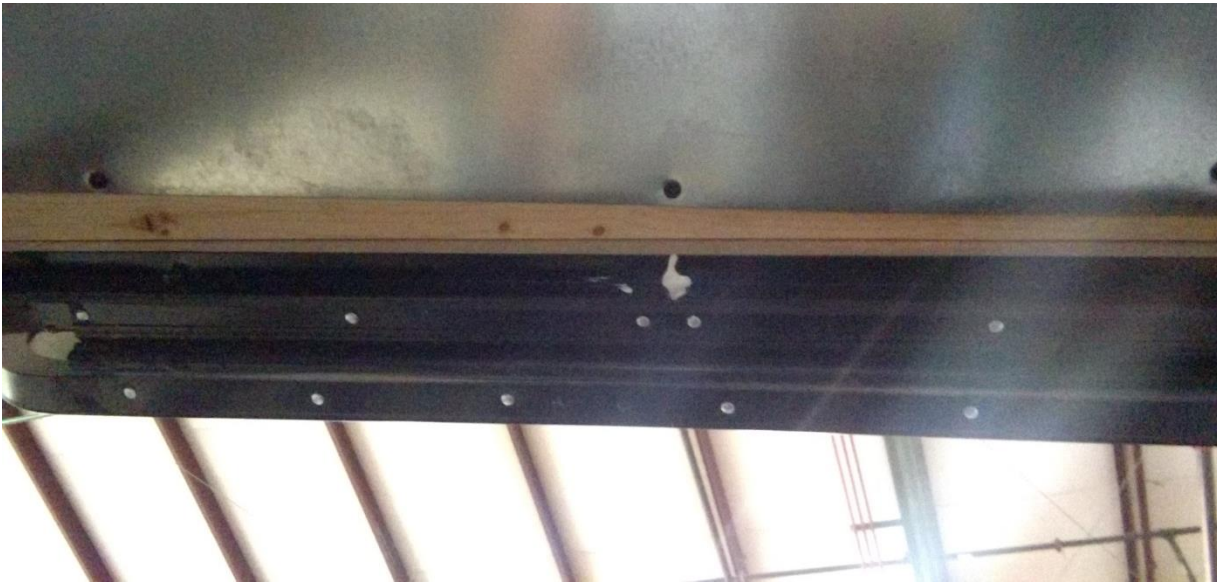
3.) Shown above is the compartment now securely fastened. We can now address sealing this compartment.
